www.rexa.com

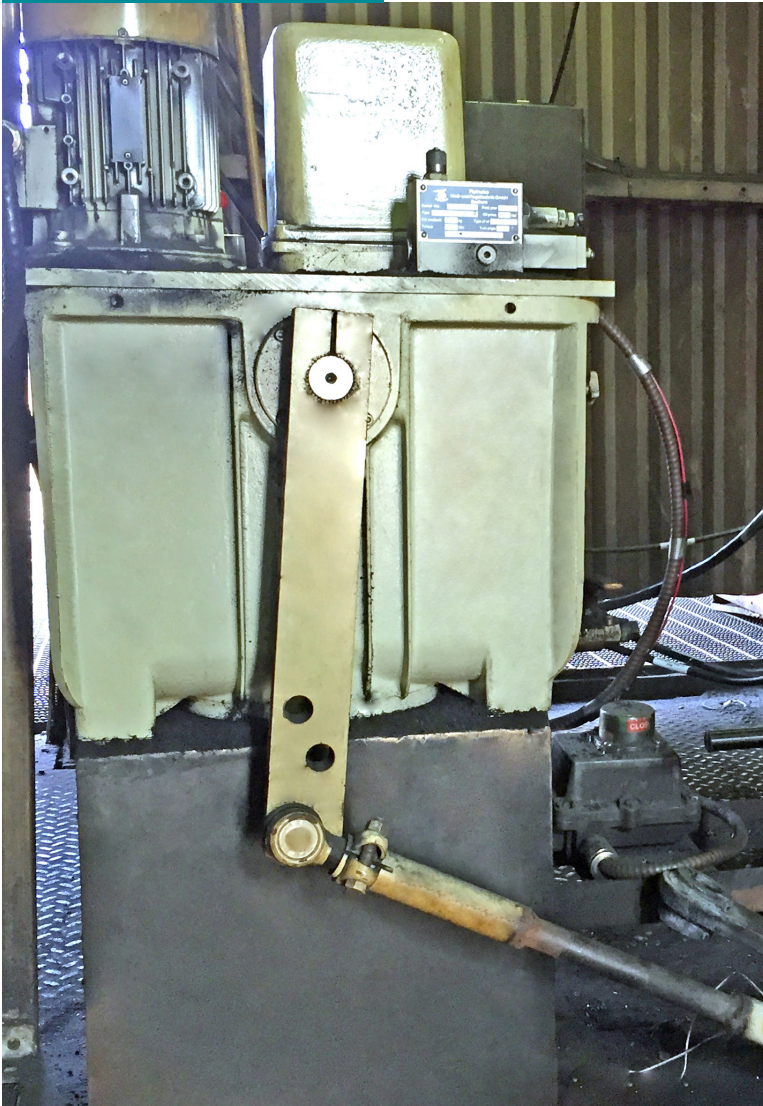
During normal operation, the cross-over valve becomes coated in tar originating from the coke over gases. Tar build-up increases the required torque to turn the valve. Left unchecked, this condition can potentially damage the valve, causing unnecessary downtime to repair. Regular cleaning ensures proper valve operation. Therefore, plant operators and technicians prefer to optimize the cleaning schedule.
